Stress Corrosion Cracking Response of 304 Stainless Steel in Aerated and Deaerated Water

W. J. Mills

Bechtel Bettis
Plant Materials Technology

SCC Response of 304 Stainless Steel in APW & DPW

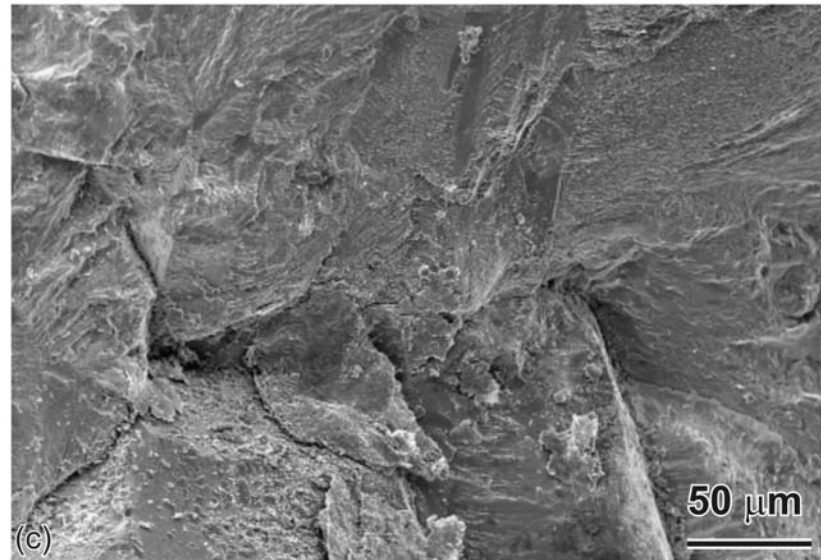
Heavily Sensitized 304 SS (WLP2-6)

Phase 5

250°C APW / DPW with SO_4 .

500s rise / 9000s hold / 500s fall.

Beyond the IGSCC with large ferrite crystals (APW), the fracture surface exhibits broad TG facets (DPW).

The fracture surface generated in 250°C DPW was predominantly TG, but isolated IG islands were found.

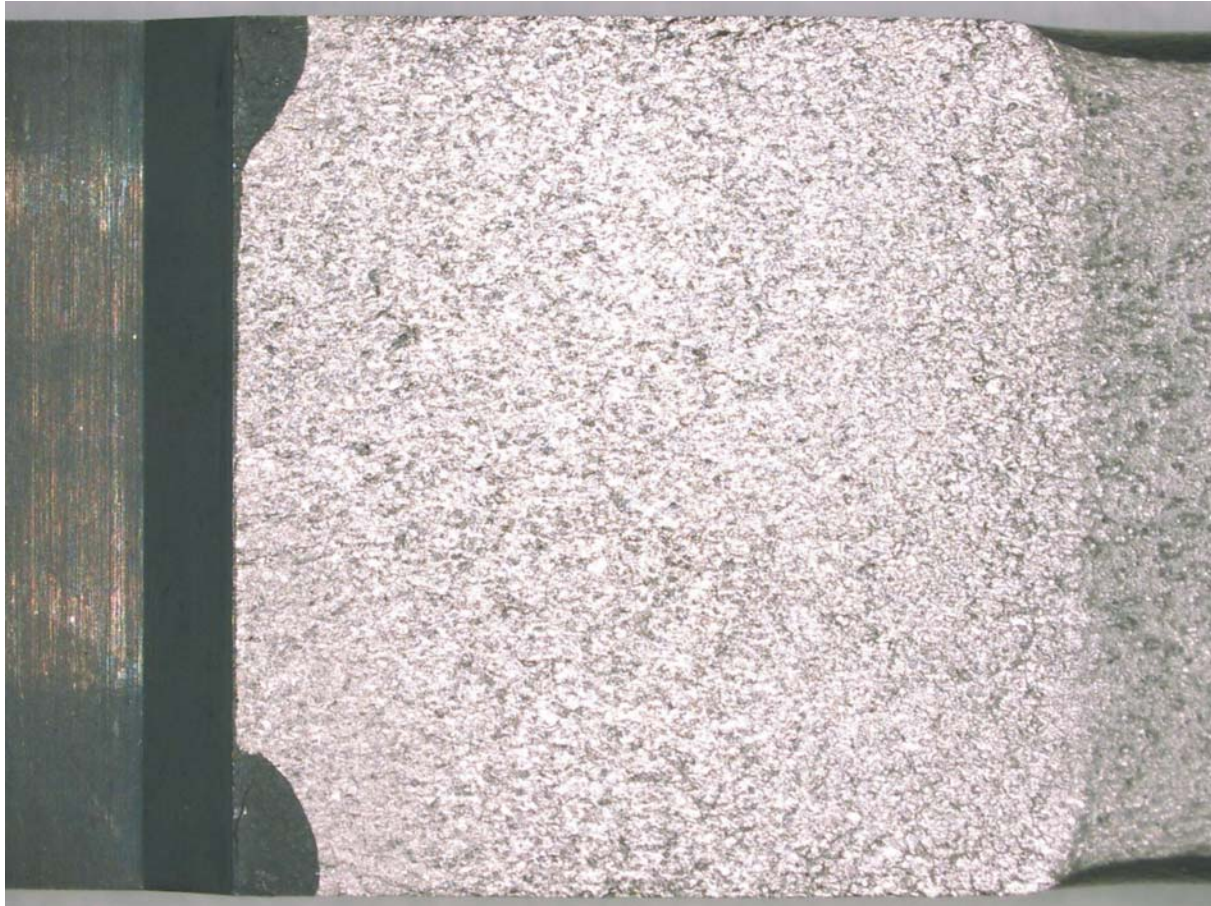
20% Cold Rolled 304 SS Specimen CT-1CR - Tested in 338°C DPW

Pre-crack was confined to two corner cracks where the notch intersected the side surfaces.

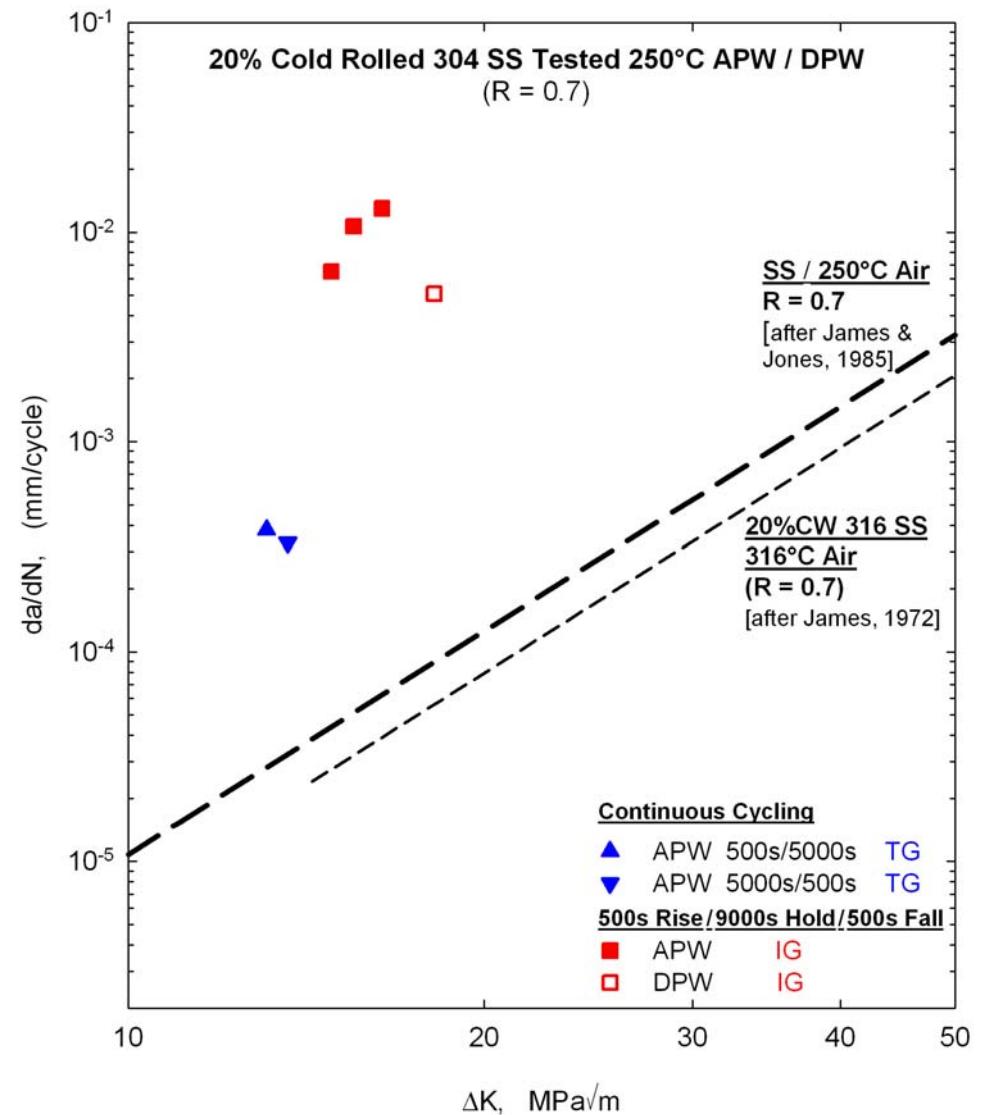
20% Cold Rolled 304 SS
250°C APW/DPW
(R = 0.7)

Continuous cycling in 250°C APW with a 500s or 5000s rise time causes an order of magnitude increase in da/dN , relative to air rates. The cracking mode was **TG**.

The exceptionally high CGRs observed when a 9000s hold time was introduced was associated with an **IGSCC** mechanism.

IGSCC continued to occur in 250°C DPW. da/dN values in DPW were slightly lower than those in APW.
